U. S. NAVAL PROVING GROUND  
DAHLGREN, VIRGINIA

REPORT NO 1037

FUZING SYSTEM FOR XSAM-N-4.  
GUIDED MISSILE DOVE; TESTING OF

Fuzing System for XSAM-N-4, Guided Missile Dove; Testing of  
-----

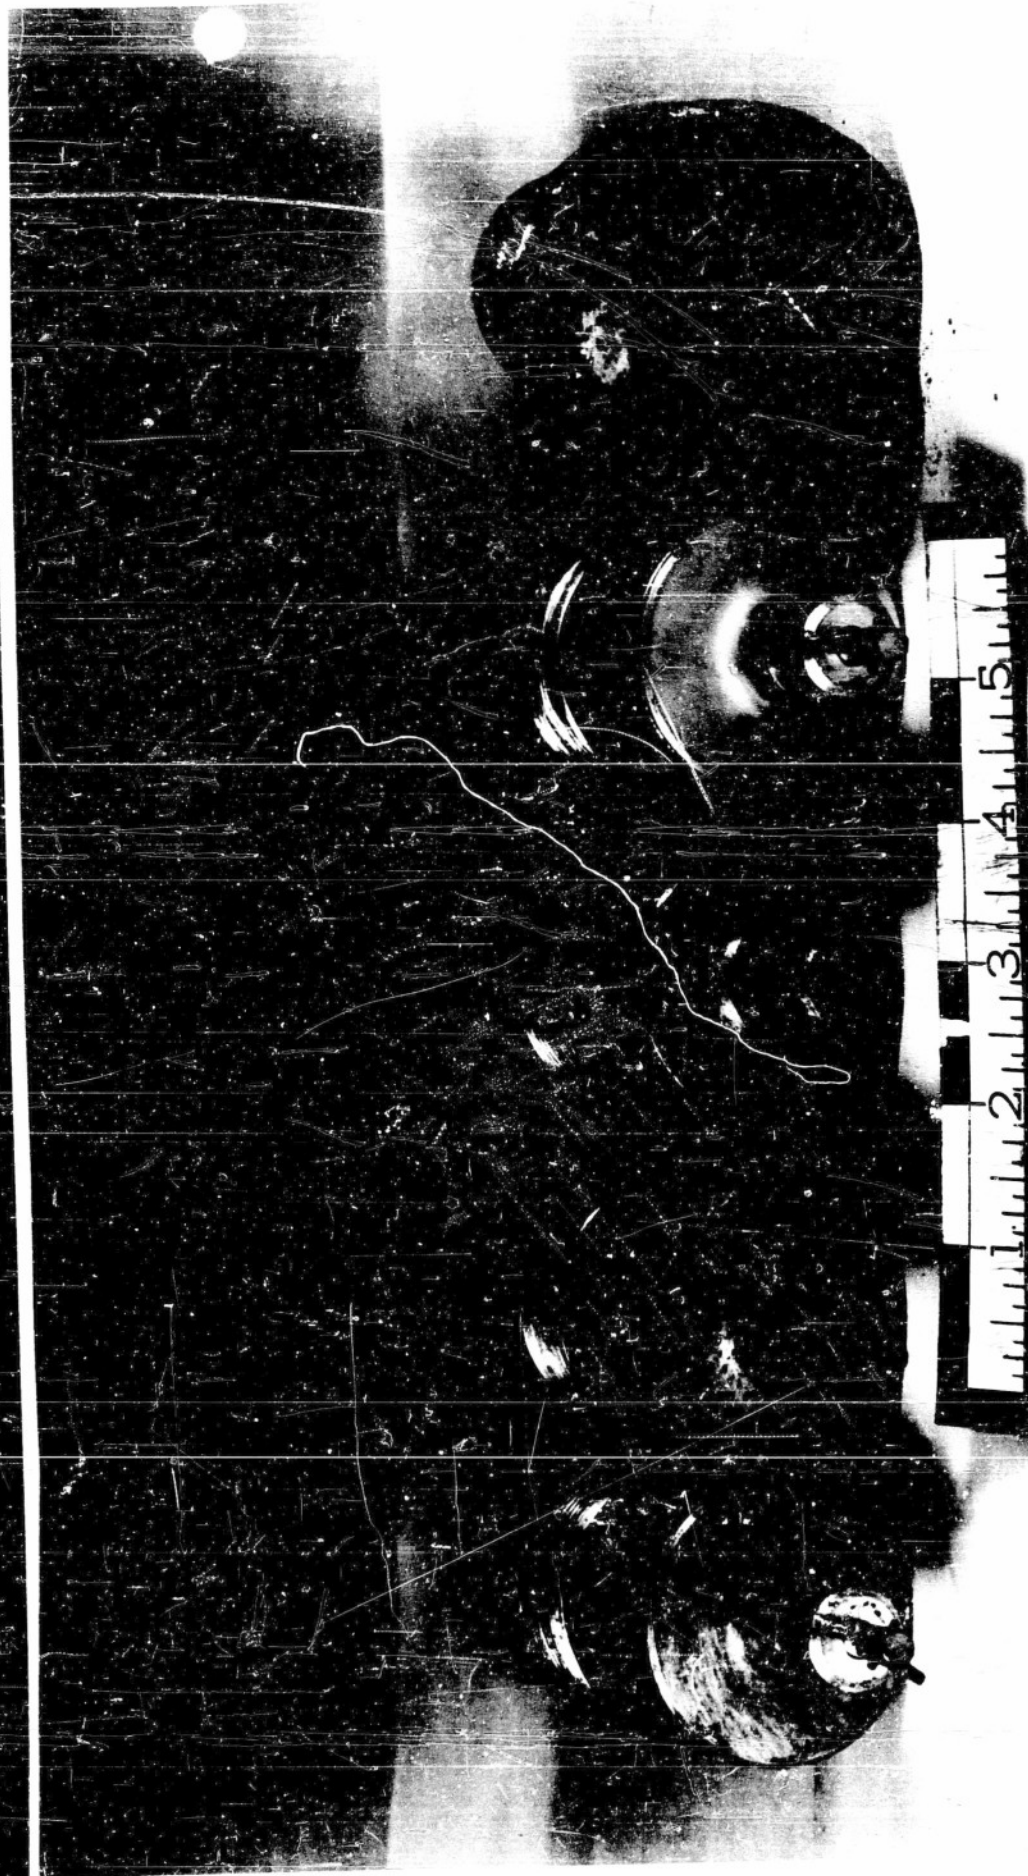
b. Fuze safety upon accidental release was satisfactory. None of the fuzes dropped incurred any internal damage due to the initial impact. Drop No. five bounced after striking the concrete target and hit on the tail, smashing the fuze. The explosive train was in a safe condition when recovered. Figure 7 shows the fuzes after recovery. Table II contains detailed dropping data and results.

13. The only items recovered were the five fuzes that were dropped to check safety upon accidental release. These were returned to the Naval Ordnance Laboratory for internal examination and retention.

Note - Figure 7, Appendix (A), is a photograph of the recovered fuzes.
